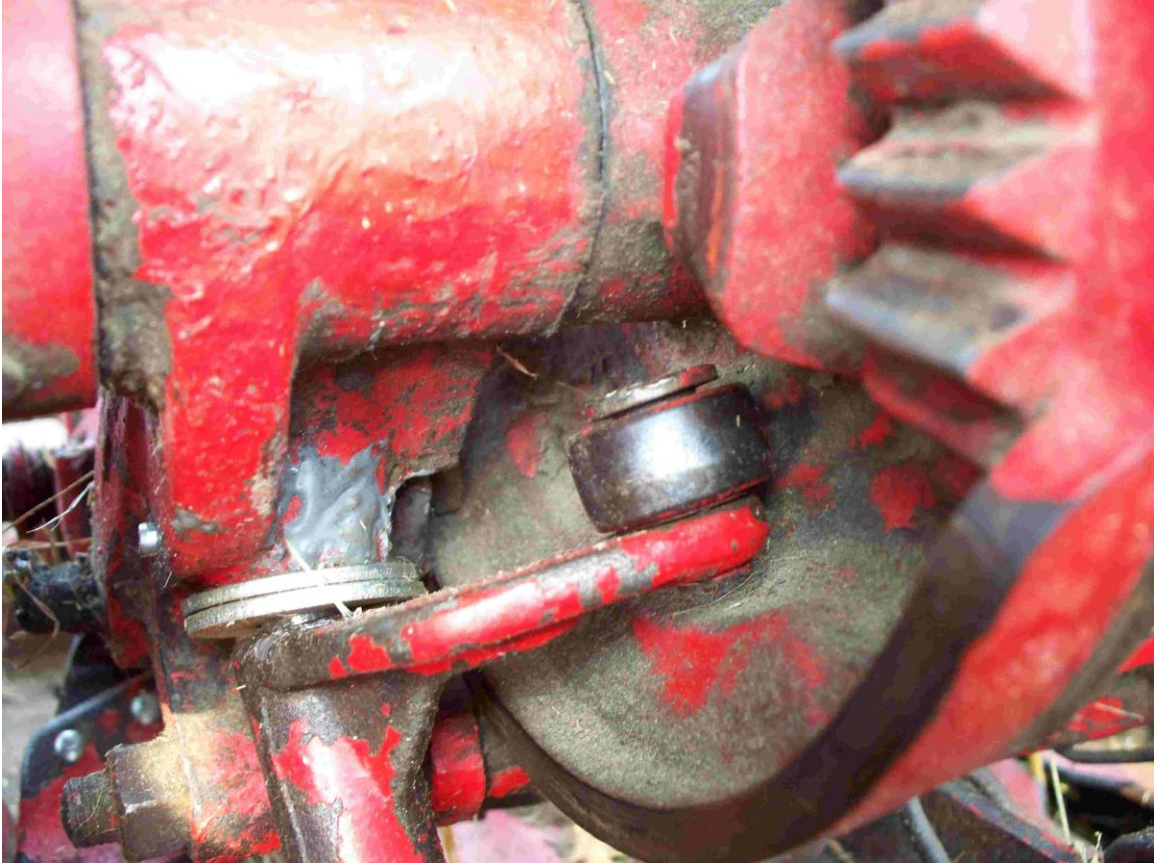
Here are some pictures as requested. This is the roller and the intermediate gear, it is hard to see but there is still an 1/8 inch between the roller and gear.

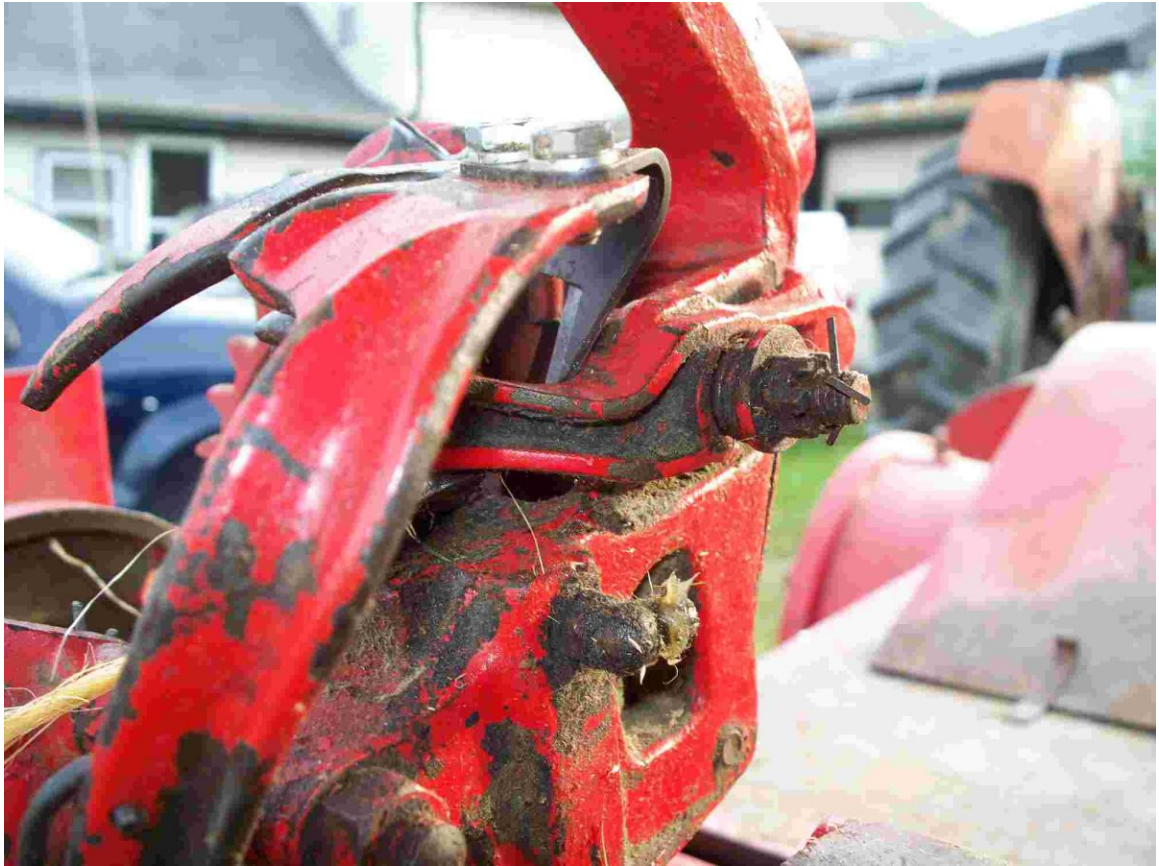
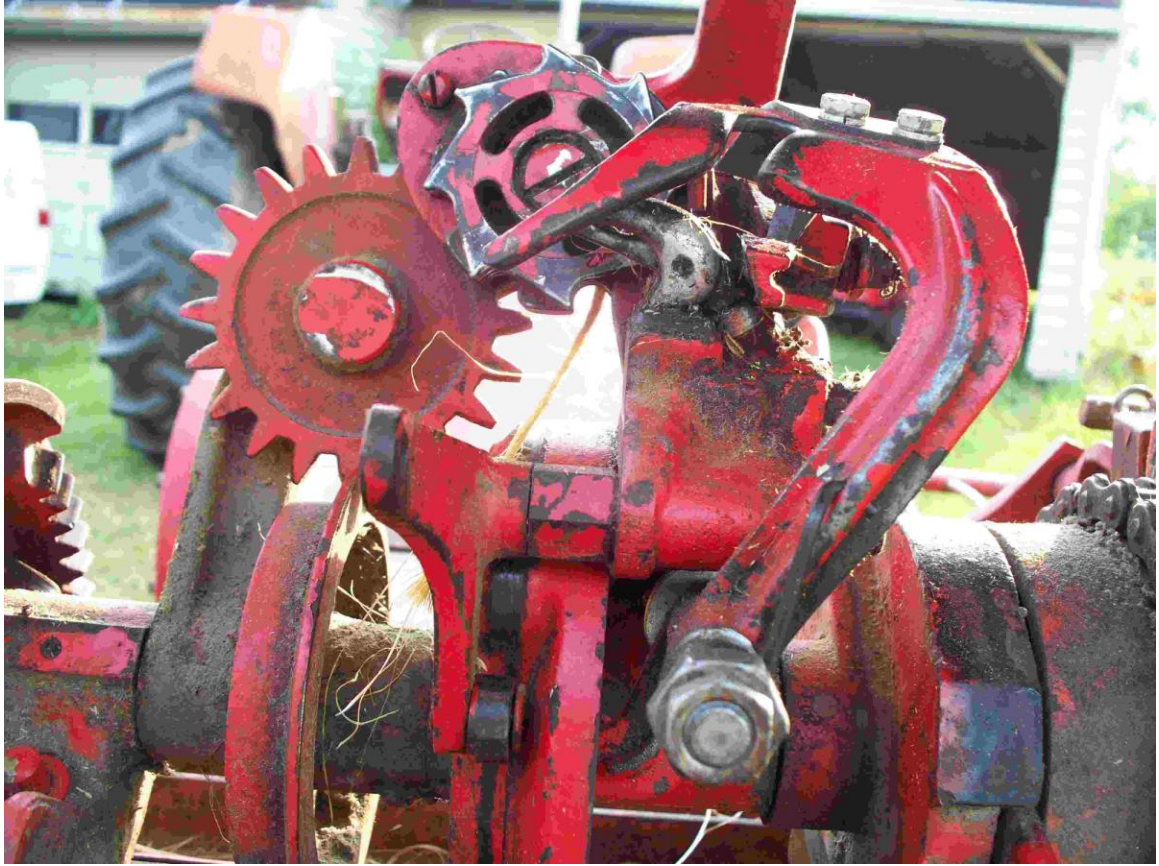
The problem I see is shown in the next two pictures. The twine knife is resting against the bill hook guide (plate that puts pressure on the bill hook as it rotates), instead of the roller contacting the intermediate gear. This limits my travel of the twine knife and it does not clear the end of the bill hook by the 3/8 to 1/2 inch as indicated in the manual.

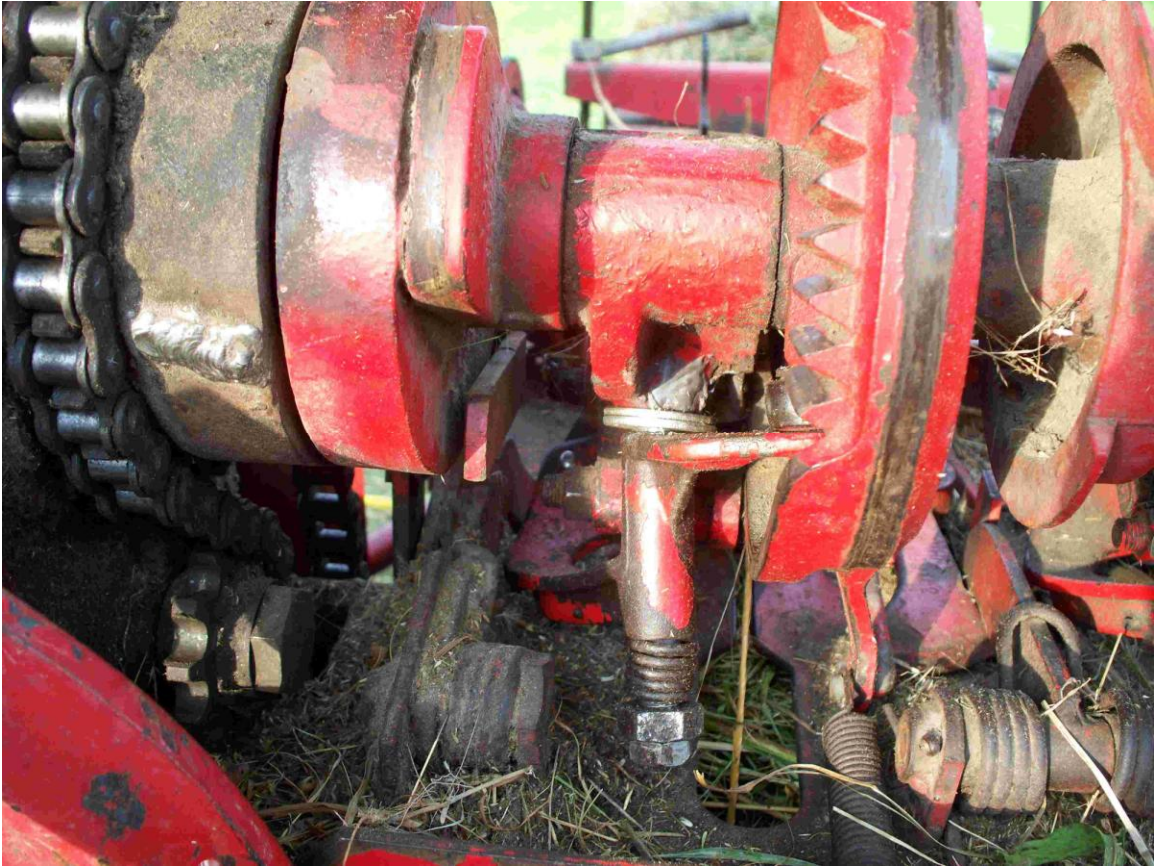
Here are some front shots of the pins and wiper arms. This one is the non working.

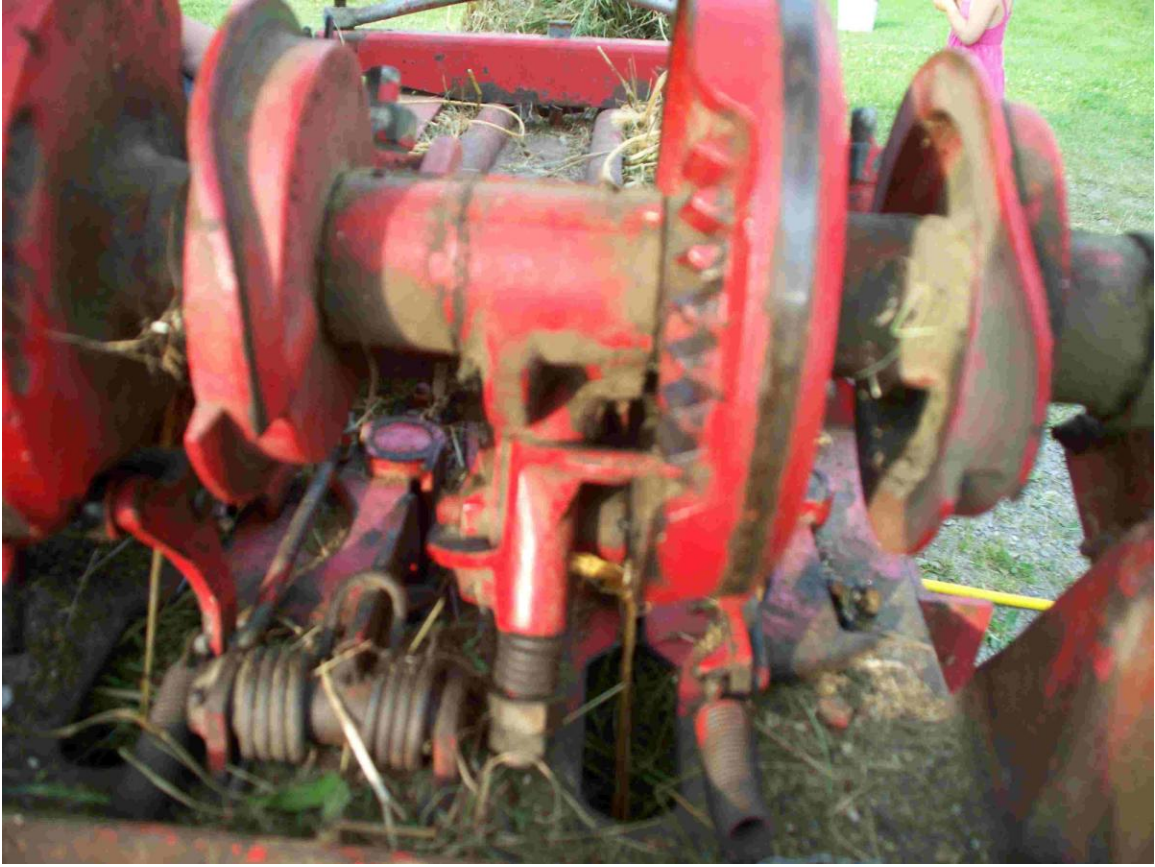
This one is the working one. You can see the difference in roller positions. This one the roller is fully inside the intermediate gear.
