## Hydraulic Lift O-Matic Cable Improvement

KA ID : KA000005114

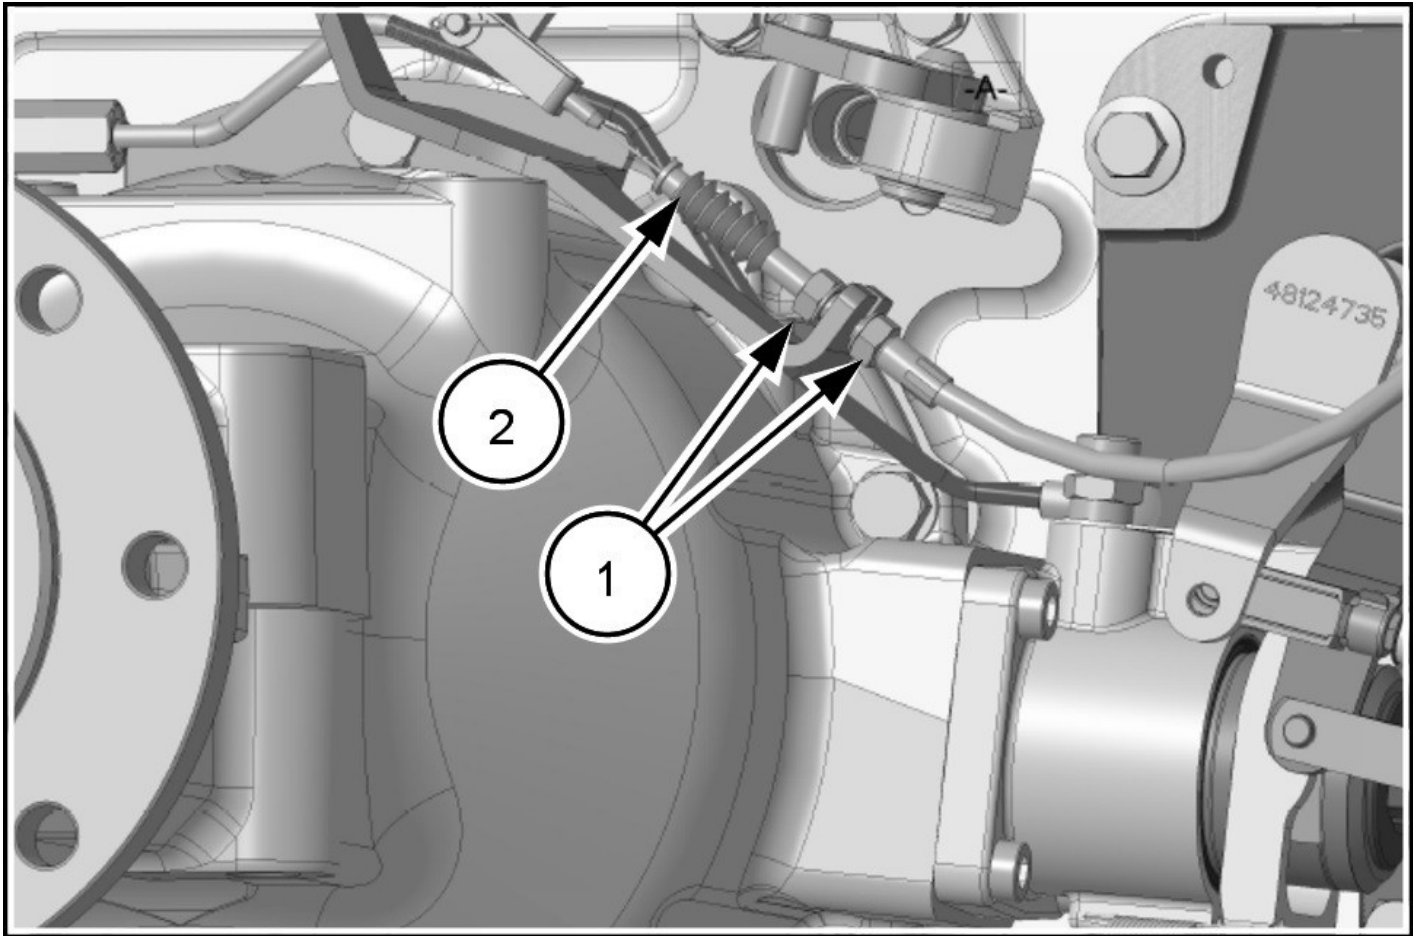
To adjust the **Lift-O-Matic™** lift speed, loosen the spiral nut **(1)** , pull the spiral **(2)** forward and torque the nut with 10 **Nm**.
